# AUGUST 10, 2023 FLOOD INVESTIGATION REPORT

DRAFT SUMMARY REPORT WARD 16

Asset Management (Water Resources)

December 14, 2023

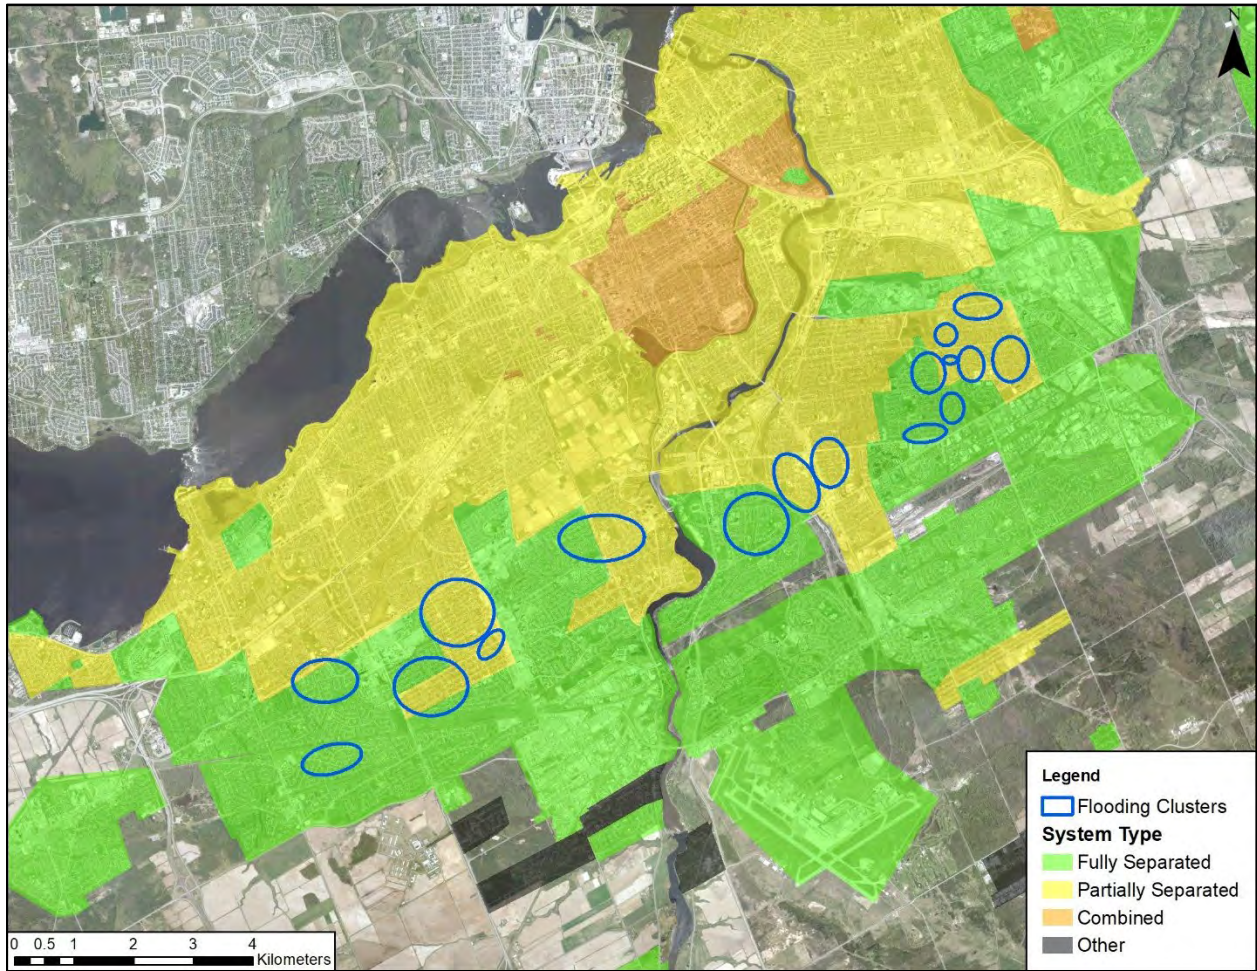
**Figure 1 – System Type and Flooding Clusters**

In 1961 the City of Ottawa passed a bylaw that required that all new sewer systems be fully separated. In other words, a sanitary sewer system would be designed for domestic flow only and a deeper storm system would capture surface runoff and foundation drain flow. The City even proceeded to separate sewers in some of the combined areas, however due to outlet restrictions, the storm sewers were shallow and foundation drains remained connected to the sanitary sewers. Also, in many areas where ditch drainage existed, the City constructed storm sewers, but again due to various drainage conditions or limitations the sewers were shallow and foundation drains remained connected to the sanitary system. ***All areas that have foundation drains connected to the sanitary sewers are referred to as partially separated. Figure 1.0 below, shows an approximate outline of the partially separated systems (in yellow) and fully separated systems (in red) in the southern portion of the City core, which was most affected by the storm.***

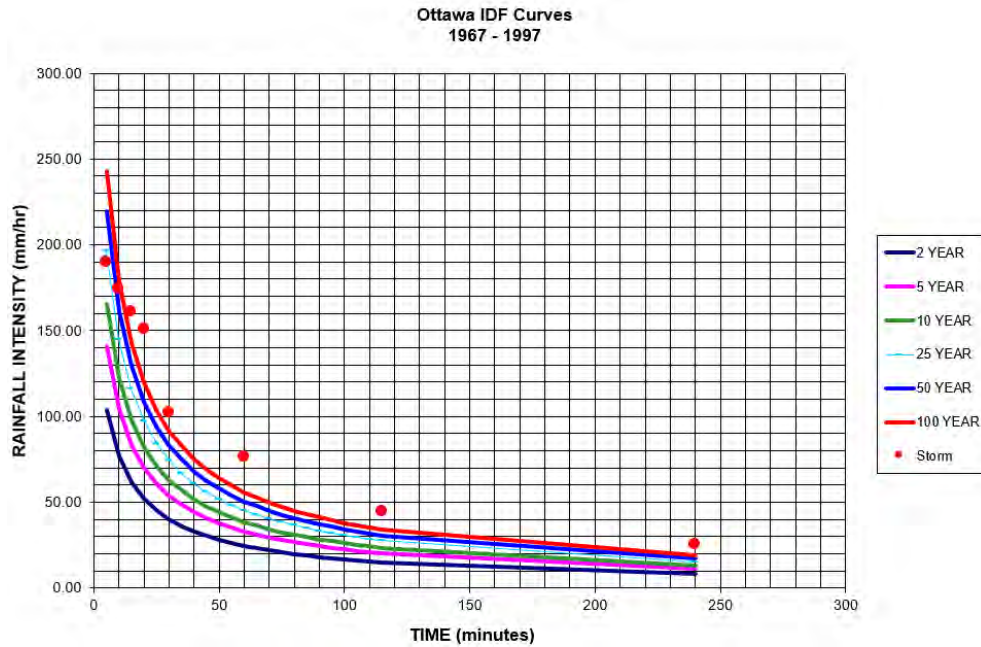
Figure 2 - Colonnade Road Rain Gauge

The average rainfall in the partially separated area was 60 mm with a peak recorded volume of 107 mm. The peak intensity of the event reached 190 mm/hr at the Colonnade rain gauge. Although the event did not reach the peak 100 year peak intensity of 243 mm/hr, it lasted longer than a typical storm, therefore the sustained intensity created an effect similar to a 100 year storm. Figures 2 and 3 below show the Intensity Duration Frequency (IDF) curves for the event at the Colonnade and Mooney’s Bay rain gauges. It is apparent from the graphs that as the storm progressed, the curve moved into the 100 year range due to the sustained intensity over a long period of time.

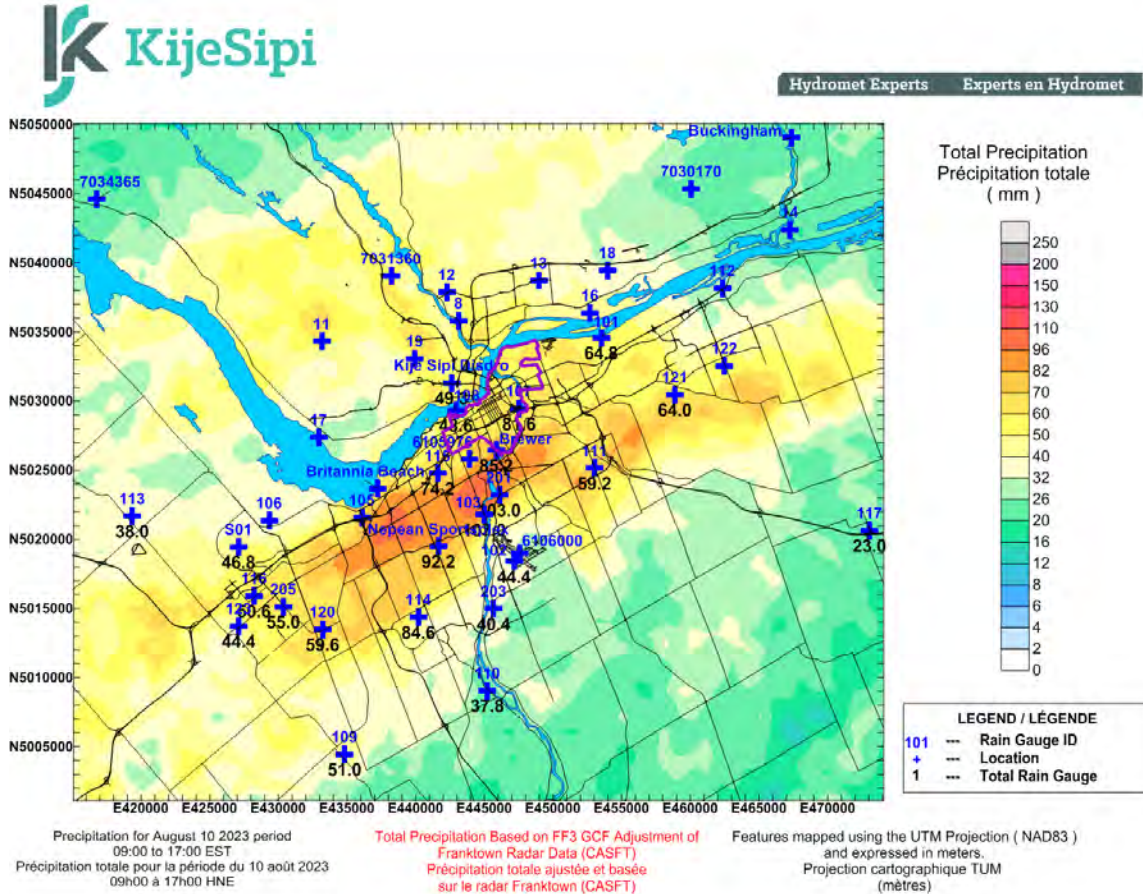
**Figure 4 – Path of Storm Peak**

Although the storm of August 10<sup>th</sup> affected the entire city, the peak of the storm followed a band near the south end of the City core. The rain gauges along that band showed the greatest rainfall

volume and intensity. Figure 4.0 shows the approximate path where the highest rainfall was experienced.

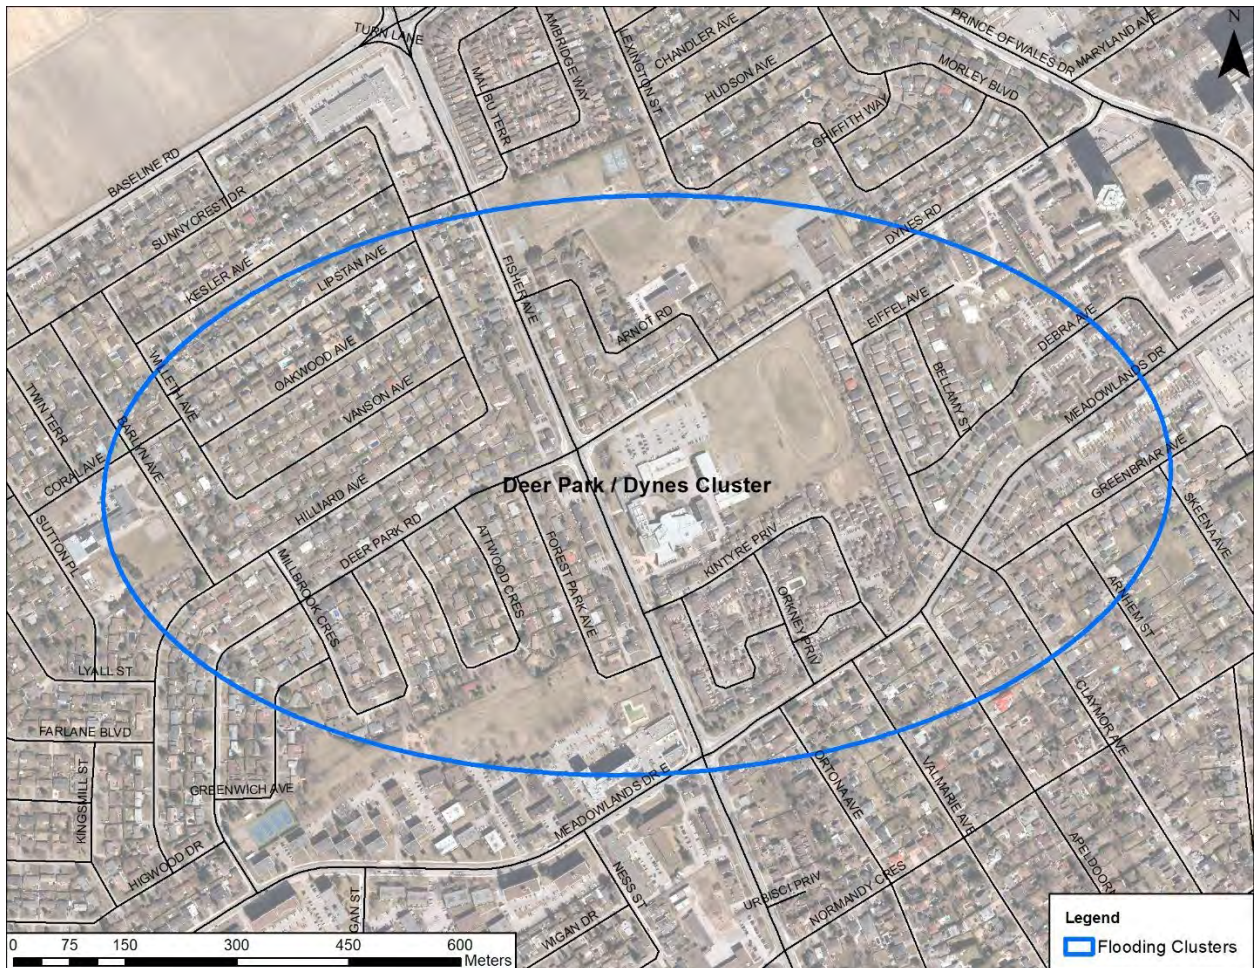
Figure 5 – Deer Park / Dynes Cluster, August 10 Flooding

- **Location and System Characteristics:** Eighteen homes (19) reported flooding in this cluster, 13 in the Deer Park area in Ward 9, and 6 in the Dynes Road area in Ward 16. The Deer Park area is fully separated meaning that weeping tiles are connected to the

storm sewer system and more prone to flooding from storm sewer surcharging. The Dynes Road area is partially separated and thus more prone to basement flooding from sanitary sewer surcharge. There was also a report of deep roadway flooding on Arnot Road by St. Augustine School and excessive roadway flow on Meadowlands from Fisher to Orton.

- **Type of Flooding:** First response data does not provide any indication as to how the properties flooded.
- **Previous Flooding:** The Deer Park and Dynes area have experienced historical flooding since 1979 with over 50 reports of basement flooding. Approximately half the flooding occurred in 2004 when Hurricane Frances caused sanitary sewer systems throughout the

- **Probable Cause of Flooding:** It is difficult to determine if flooding was due to a surcharged sanitary system or surcharged storm system without confirmation of the water entry point to the homes. Computer simulations show that the Dynes Road area would have been more at risk from sanitary sewer surcharge. We are still soliciting and receiving flood questionnaire and will have a better understanding of the cause of flooding in the near future.

- **Next Steps:** Communication with residents will be required to explain the benefits of installing backwater valves and how to protect homes from flooding. The local storm and sanitary sewer system will also be reviewed using the computer models built for the previous sewer upgrade projects to see if any additional improvements can be done to reduce the surcharge level during critical events. The overland flow system on Arnot will also be looked at to see if there are way of minimizing the accumulation of water at the low point. It must be noted however, that grading limitations may greatly hinder such an undertaking and that affected homeowners may need to take additional measures to protect their properties if the ponding poses a risk to their building.

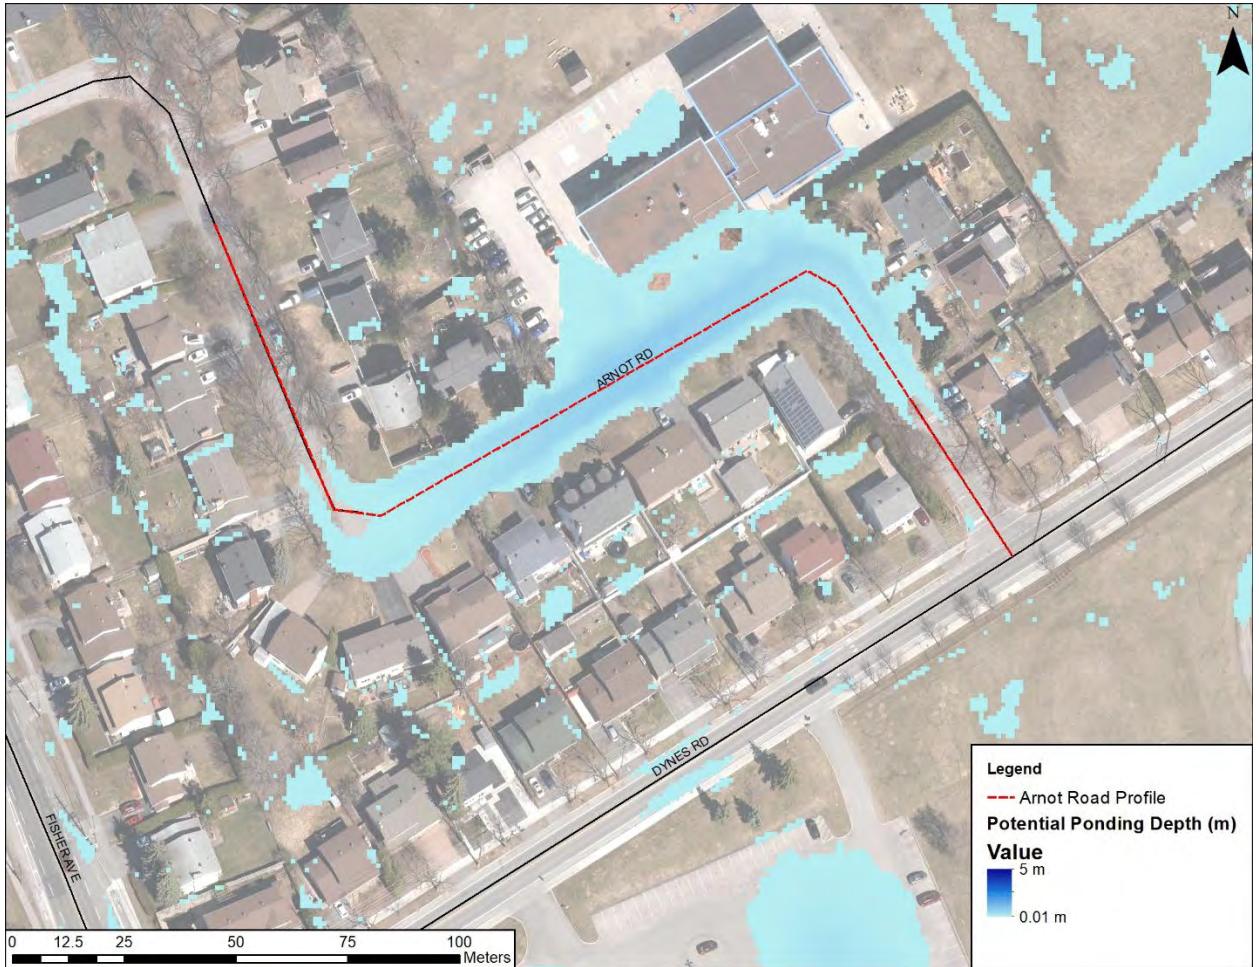
The roadway flooding on Arnot Road is due to a low point in the road. Water must pond to a depth of approximately 0.8 m before spilling to Dynes Road. This is only problematic during extreme rainfall events. There were also reports of deep water on Meadowlands from Fisher to Ortona, however there are no ponding low points in that area and the depth of flow is simply the depth of the overland drainage system during critical events.

**Figure 6.1 –Ponding Depth on Arnot Road before spilling to Dynes Road**

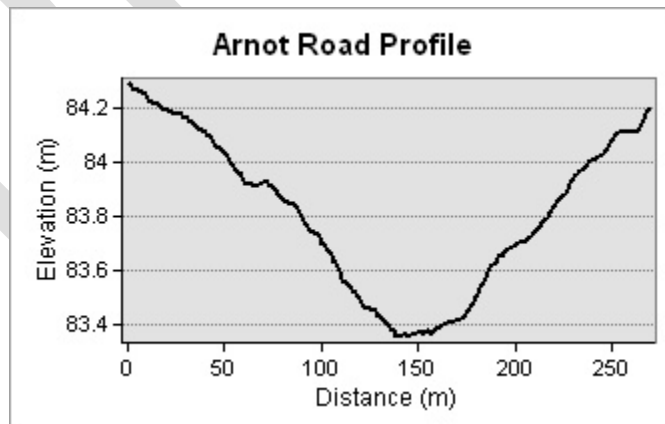
**Figure 6.2 – Arnot Road Profile (extent shown in Figure 6.1)**

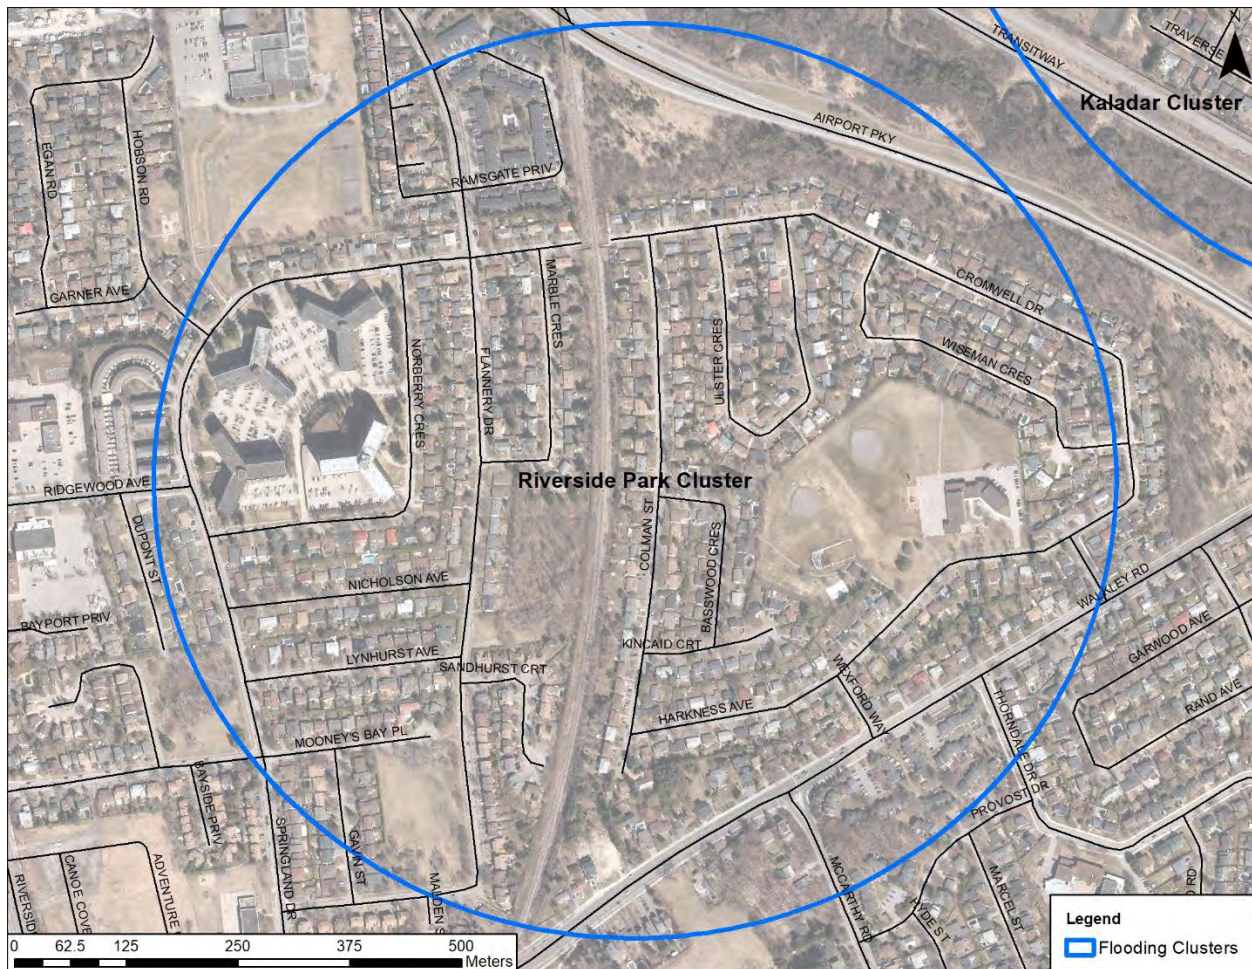
**Figure 7 – Riverside Park Cluster, August 10 Flooding**

- **Location and System Characteristics:** Eighteen (18) properties reported flooding in the August 10<sup>th</sup>, 2023 event. The Riverside Park area was developed in the mid-1960s and is fully separated, which means that weeping tiles are connected to the storm sewer system. This area is therefore more at risk of flooding due to storm sewer surcharge than from sanitary sewer surcharge.

- **Type of Flooding.** First response data does not provide any indication as to how the properties flooded. Resident flood questionnaires reported flooding of reverse driveways due to overland flow and flooding from the floor drain in at least one case. There were also reports of street flooding on Harkness, Lynhurst, Nicholson, Springland, Norberry and Ulster.
- **Previous Flooding:** There are approximately 30 reports of basement flooding in this area from previous years. Most of the flooding occurred during high intensity thunderstorm events, such as the ones in 1996, 2009 and 2011. The flooding reports were interspersed throughout the area for each event, which did not create specific clusters. A review of all flooding events, though, show that this area does in fact form a cluster due to flooding from storm sewer surcharge.

- **Previous Investigations and Remedial Measures.** As noted earlier, previous flooding events did not identify clusters in each individual event, which would have indicated that the problem was related to the private property. As such, no system wide remedial measures were investigated and/or implemented.
- **Current Investigation:** A review of the sanitary sewer model shows that it would not have surcharged to reach basement elevations during the event of August 10<sup>th</sup>, thus making it unlikely that sanitary sewer surcharge was the main cause of flooding. The storm sewer model however, showed significant surcharge during such a critical event, up to street level, meaning storm sewer surcharge most likely backed up around weeping tiles and entered homes through foundation cracks and joints.

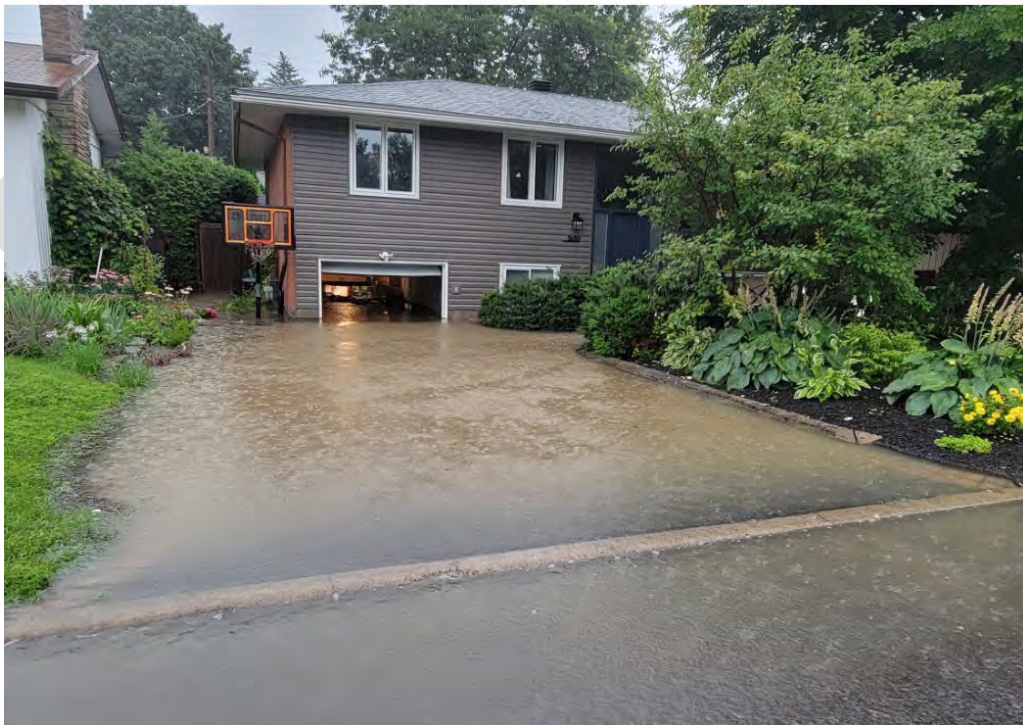
In addition, there were numerous reports of overland flooding on various streets. An analysis of the overland drainage system shows a significant amount of overland flow coming from Pauline Vanier Park. This runoff would have flowed behind the homes along Colman Street flooding rear yards and a reverse driveway on Colman as water flowed from the rear yard to the street (see image below). The resident on Colman also noted water coming out of the basement plumbing. This would indicate that the sanitary system was most likely impacted due to flooded basements as water drains back to the sewer via the floor drains.

**Figure 8 – Flood on Colman Street**

- **Next Steps:** The flooding situation in Riverside Park is complex in that the overland system is creating much of the problems. Excess flow from Pauline Vanier School and park is spilling into rear yards and flooding homes. The City will study this area in greater detail to see if storage in the park can be implemented to reduce the overland flow. Streets with low points are another issue. This area was designed and built in the early to mid-60s using the standard of the time. Overland drainage was not taken into consideration as it is today, and as such water accumulates in low points and spills through private properties. This is especially problematic if there are reverse slope driveways on the street. In many instances, a hump can be added to reduce spillage into the driveway, but that is often not enough protection for critical events. Communication with residents will be needed to explain the flooding risk so that they can find ways to further protect their properties. The City will also look at ways of reducing flow accumulation at low points if feasible. Note that any option that includes storage in parks or other locations, will most likely require an EA study, which will add one or two years to the study period.

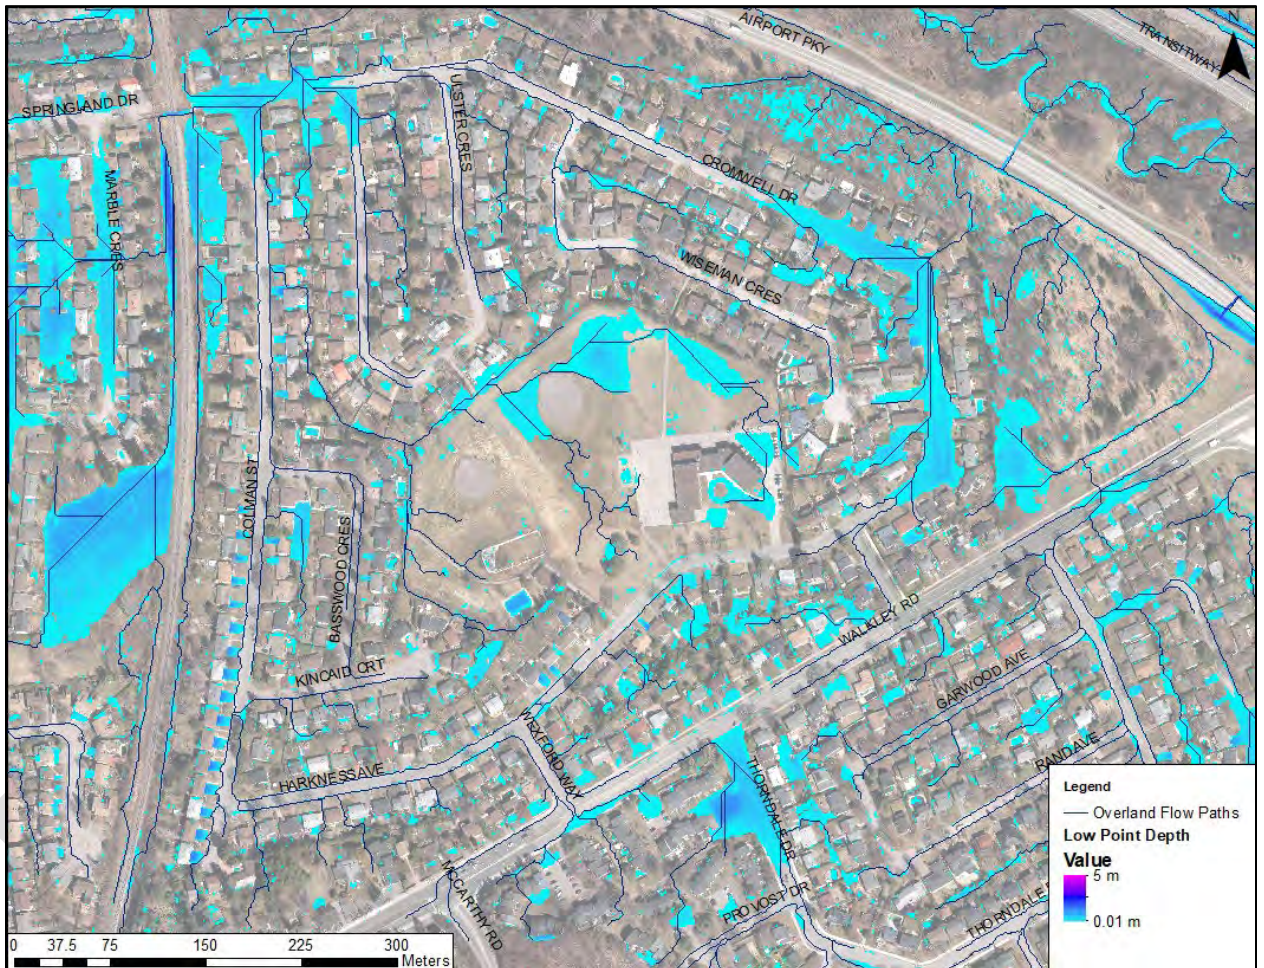
**Figure 9 – Riverside Park Cluster, Overland Flow Paths and Low Points**

The image below shows the overland flow paths and low points in this area, which clearly shows the flow from Pauline Vanier Park into the rear yards on Colman.

Streets that report flooding include Harkness, Lynhurst, Nicholson, Springland, Norberry and Ulster. In many of these instances, reverse slope driveways were impacted, and basements flooded as a result. Low points have been observed on Lynhurst, Nicholson, Springland and Norberry and unfortunately these low points were part of the original design and cannot be removed without re-grading the neighbourhood.

- **Probable Cause of Flooding:** Surcharged storm sewers led to basement flooding in this cluster area as well as excess overland flow in the rear yard system along Colman Street.

The storm sewer system will also be looked at in greater detail to see if the level of surcharge can be reduced by restricting catch basin inflow. This will be problematic though, because in new subdivisions this is done by restricting flow into the sewers and managing excess water on the streets. In our case, street drainage is already a major problem, and we would be exacerbating it by adding more surface drainage.
